Seguso Residence – 770 Enfield Court
Request to keep a recently Installed Fence with Gate, Vegetation,
and Drains within the E-4 Canal Right-of-Way
North of Lake Ida Road, East of I-95
Project #RW-25-0277

Nicole Smith - Permit Supervisor
Board Meeting – March 11, 2026
Agenda Item # **DRAFT**

Re: Request for Reconsideration

Historic Banyan Tree – Southeast Corner of Clubhouse

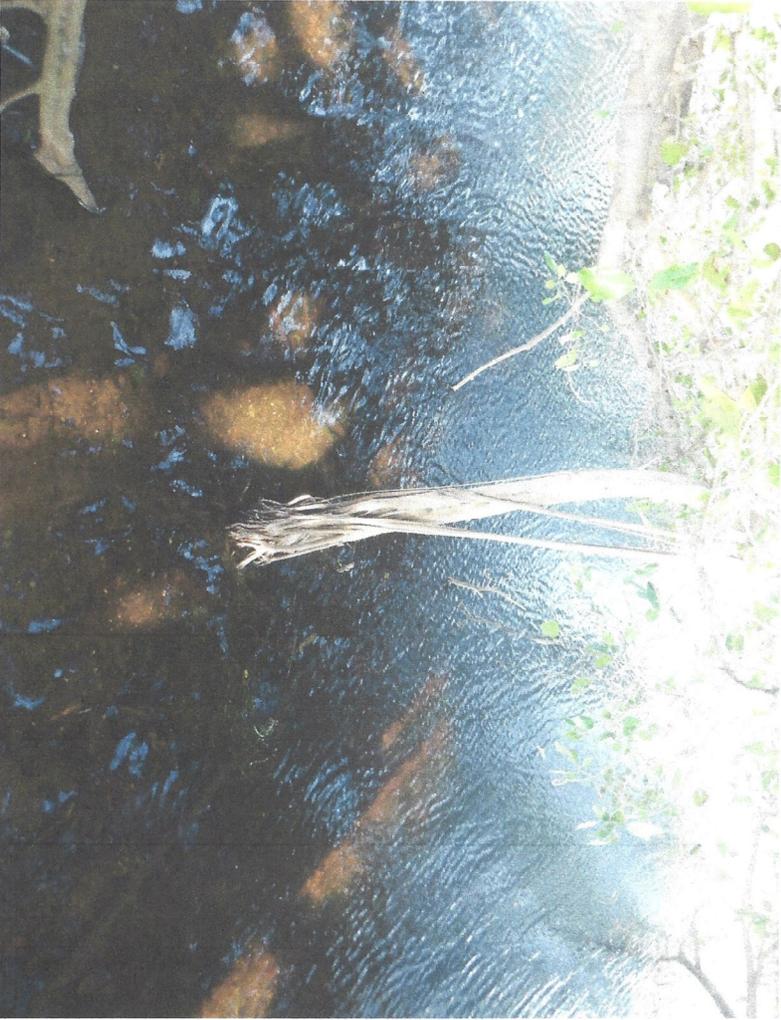
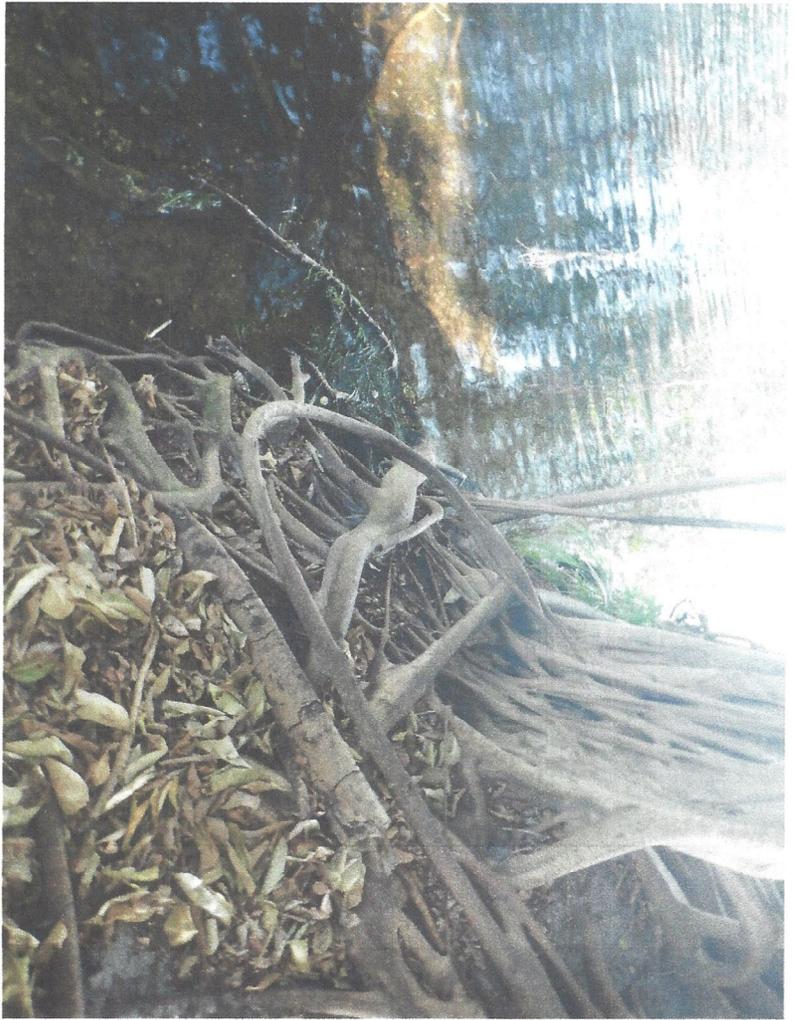
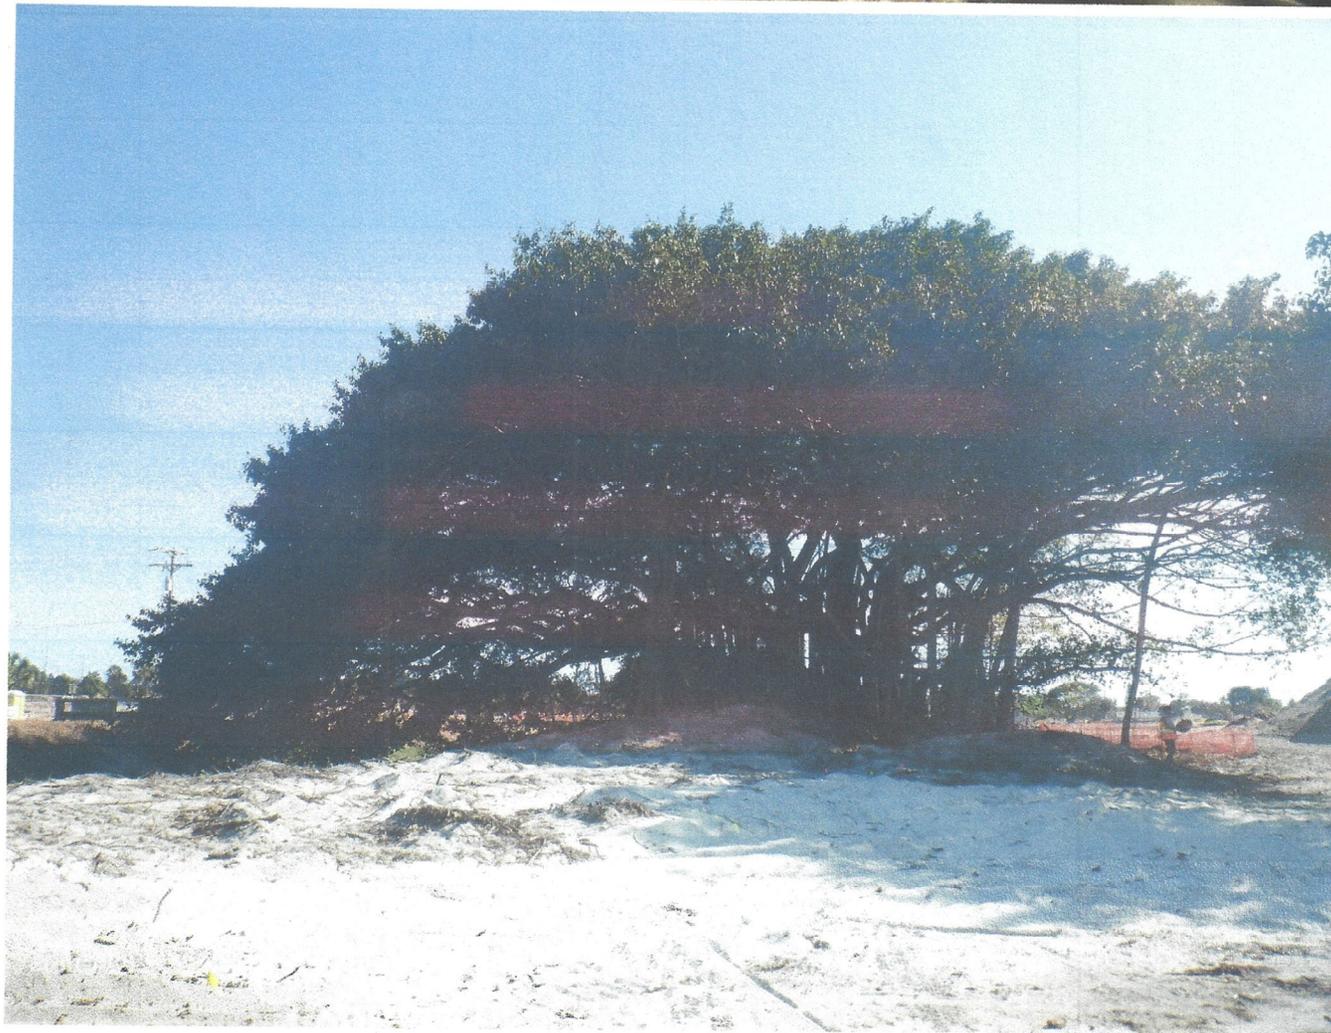
Overall, the banyan appears to be in very good condition. I observed no signs of significant past pruning, storm damage, stress, or decay. To my knowledge, our company has not previously trimmed this particular tree.

1. Approximately 98% of the tree is located within the LWDD easement.
2. The canopy extends significantly over the drainage canal, limiting maintenance access.
3. The mature root mass has expanded into the canal, seeking water sources and establishing growth within the canal bank managed by LWDD (see attached photos).

Based on the photographs and site assessment, the original trunk appears to have been approximately 30 feet from the canal's edge. Over the decades, aerial roots have established themselves, expanding the overall footprint of the tree. In addition to the primary trunk, there are approximately seven to eight secondary trunks formed from aerial roots, each now functioning as independent structural supports, with trunk diameters (DBH) ranging from approximately 8 to 14 feet.

- Remove the canopy portions that overhang and obstruct access to the canal for maintenance.
- Remove the root mass and appendage growth encroaching into the canal bank and waterway.
- Selectively remove appendages extending from the main trunk to allow for safe excavation of the root mass without compromising the primary structure of the tree.
- Create sufficient clearance to allow proper equipment access for ongoing LWDD canal maintenance.

This process would likely involve removing approximately 45–55% of the tree’s secondary growth. Following this structural reduction, I would implement corrective and restorative pruning in accordance with ANSI A300 standards.

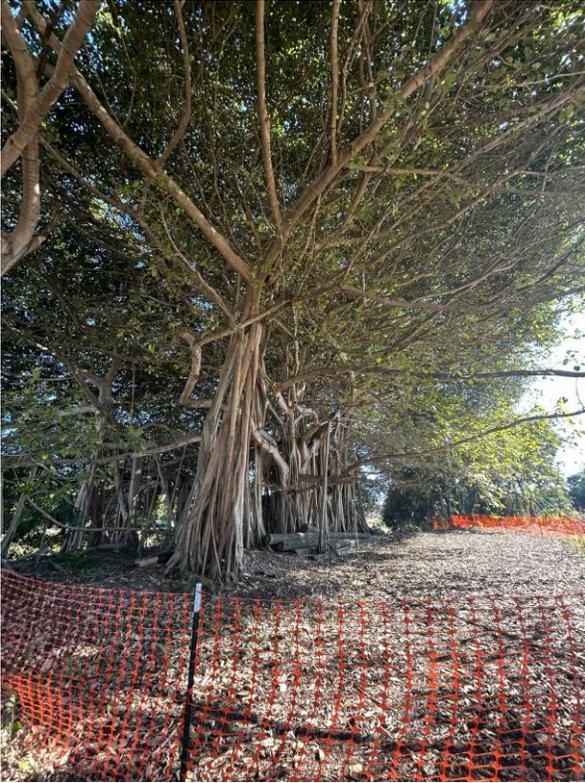
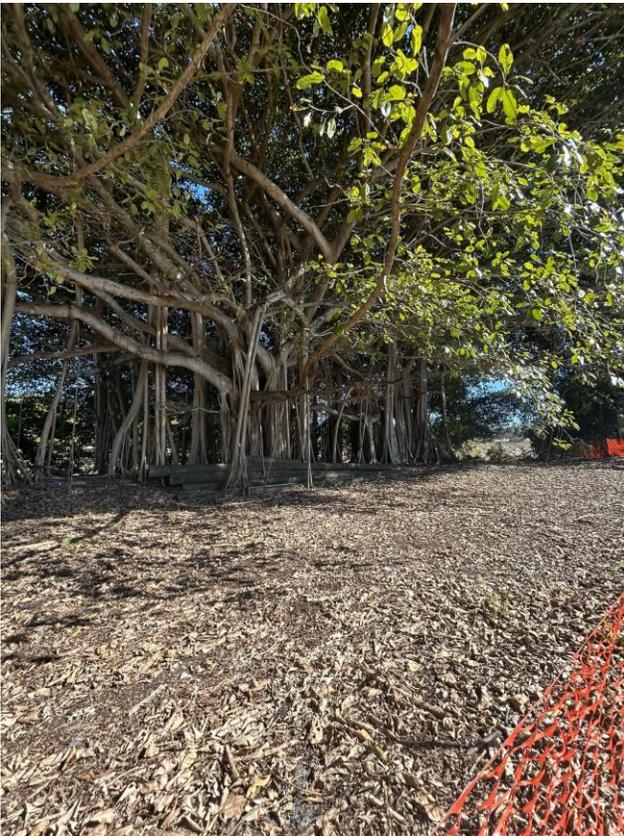
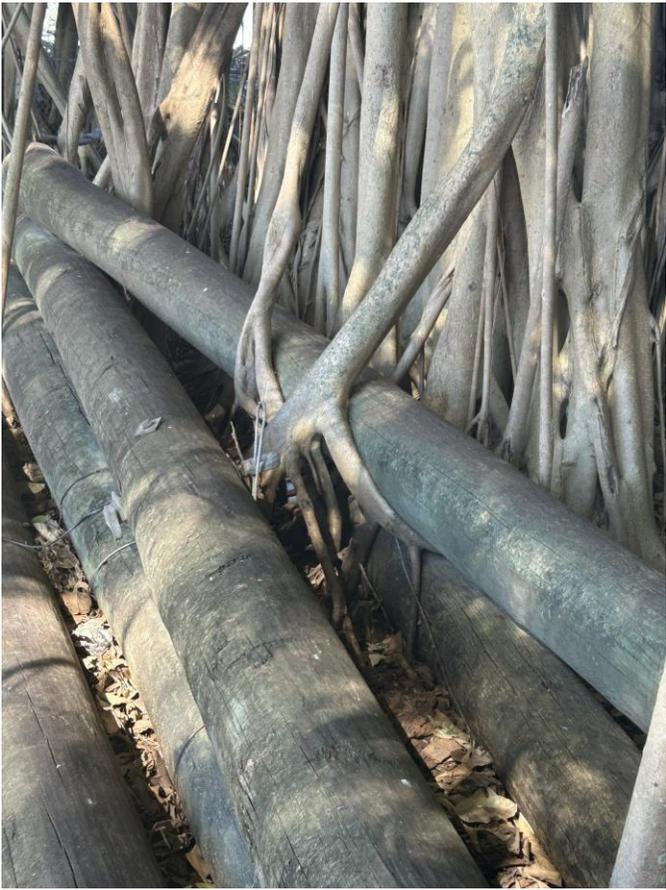
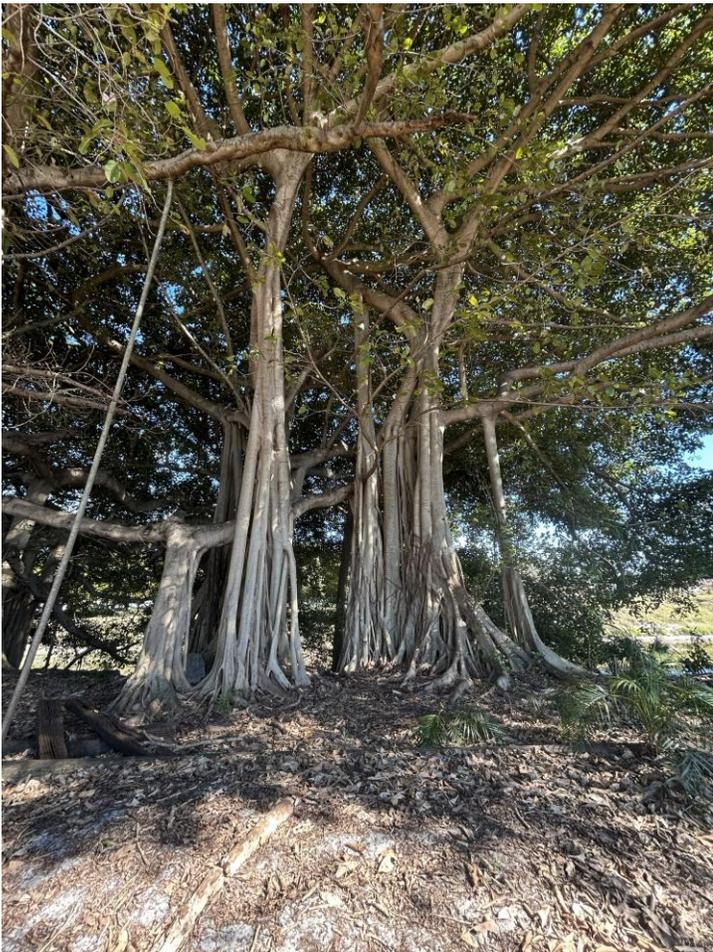
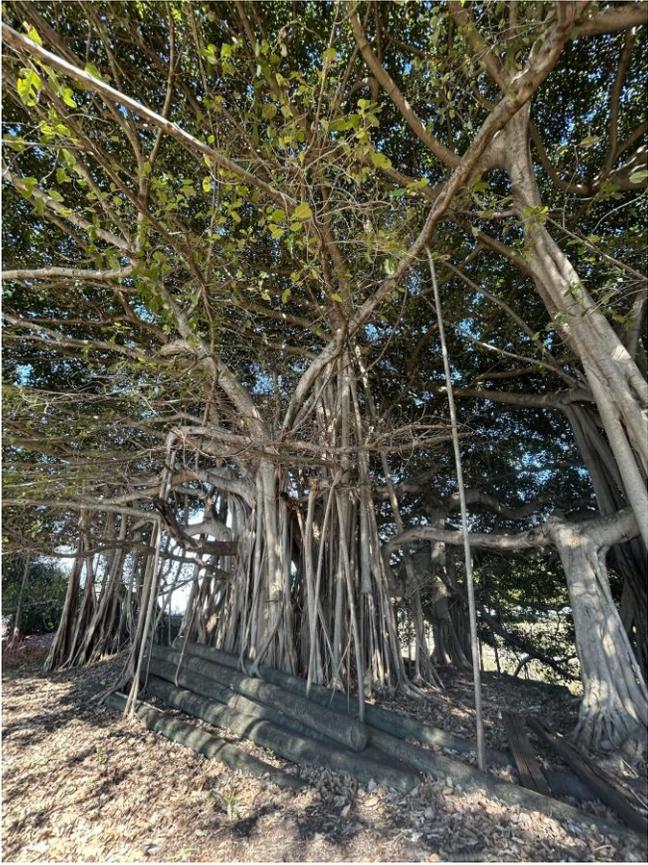
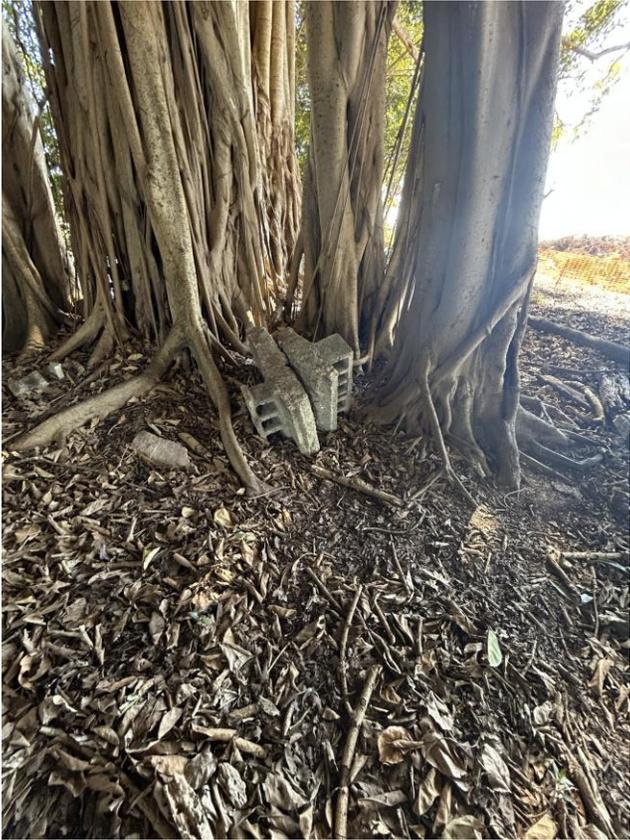
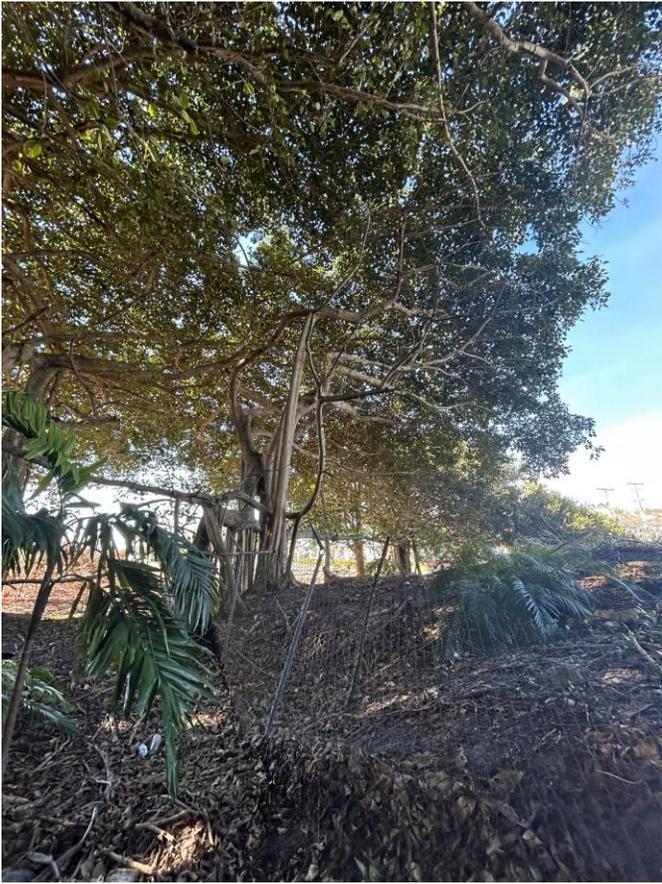
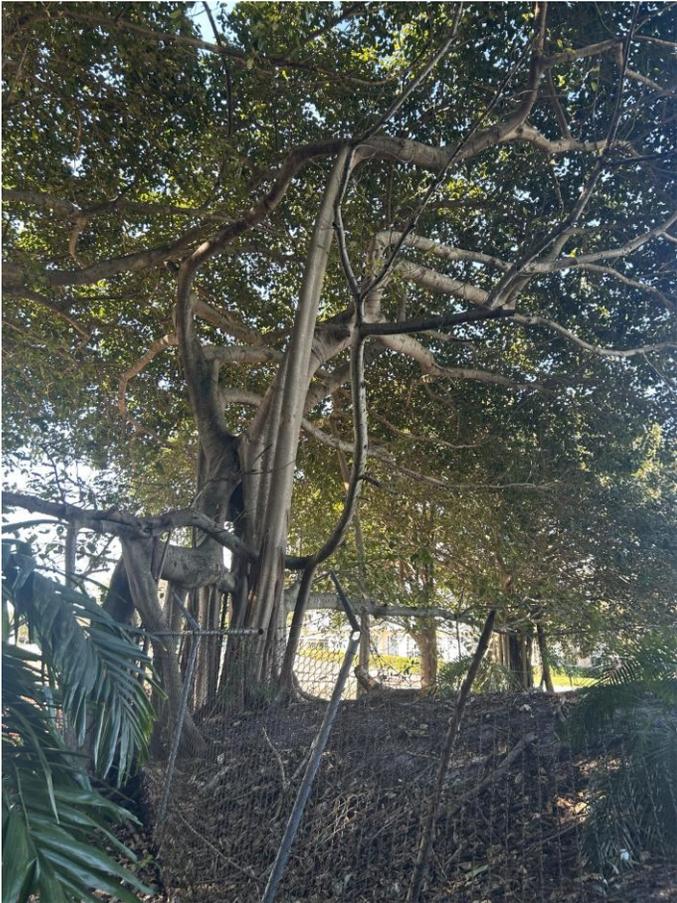
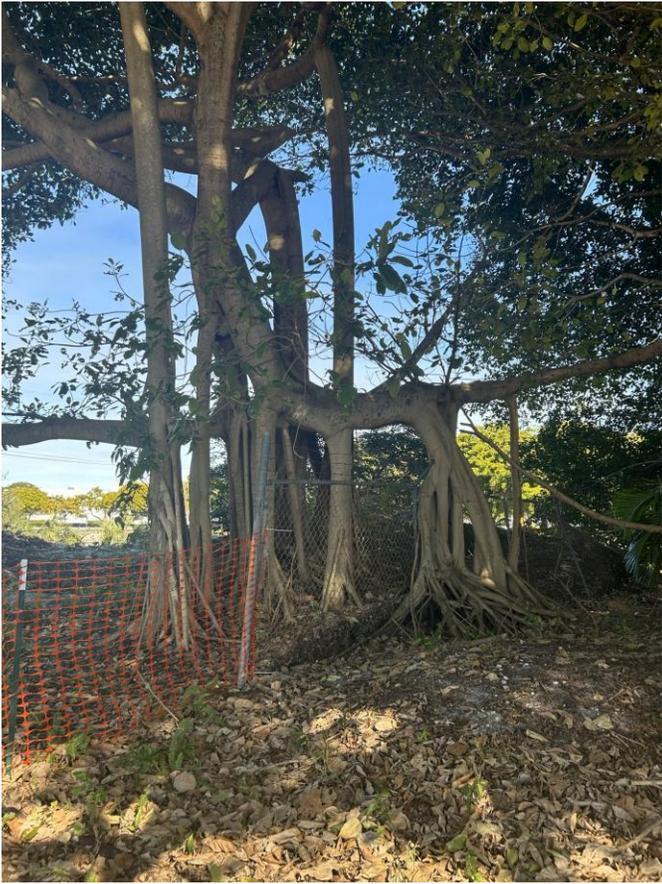
Photographic Documentation

- The canopy is dense, vigorous, and exhibits strong foliar color and uniform distribution.
- Minimal deadwood was observed within the crown.
- No widespread decay, disease, or pest infestations were noted at the time of inspection.
- The tree exhibits extensive aerial root development typical of mature Banyan trees, which contributes significantly to its long-term stability and anchorage.

Structurally, the tree appears sound. The multiple trunks and aerial roots form a broad, well-distributed load-bearing structure that enhances resistance to wind and storm events.

- Several old utility poles are present at the base of the tree, with aerial roots growing around and incorporating them. Removal of these poles is recommended to reduce long-term interference with root development.
- Minor debris, including old concrete materials, was observed within the root zone. Removal of this debris would benefit soil conditions and root health.
- Light pruning of minor deadwood may be performed as routine maintenance but is not urgent.

- Establishment of tree protection fencing at or beyond the dripline
- Prevention of soil compaction within the root zone
- Avoidance of trenching, grade changes, or heavy equipment traffic near the tree
